Cronus

Release

Notes

Cronus Hardware Release Notes

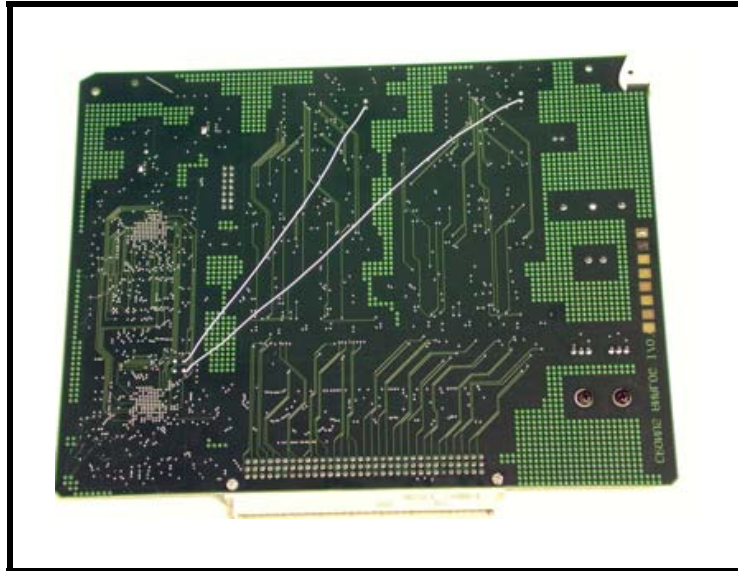
FIGURE 1. Wire Placement on the Cronus Front Card

- The CODECs get out of sync causing the audio on all 8 ports to be distorted, which was fixed by adding two wires to the existing board. To Rework the Cronus card, see “Codec Synchronization (Rev B to Rev C)” on page 5.
NOTE: If the card you have is 9030-7784-000 Rev C or higher, it has already been modified and does not need to be upgraded.
- When a party line is assigned, “clicking” is heard in the background due to crosstalk between analog input signals and digital UART signals which are assigned next to each other on the backplane connector.
- The analog input/output gain structure of Cronus is not in line with ADAM and Zeus. To upgrade the gain structure, see “Gain Enhancement (Rev C to Rev D)” on page 6.
NOTE: If the card you have is 9030-7784-000 Rev D or higher, it has already been modified and does not need to be upgraded.

If you currently have the old Cronus AIO board and need to fix the audio distortion from the CODECs being asynchronous, do the following:

1. Identify test points TP4, TP18, TP19, and TP28 on the front side of the board.
2. Turn the board over to the backside.
3. Using Kynar type jumper wire, connect TP4 to TP18 and TP28 to TP19.
4. Turn the board over to the front side.

5. Using an ohm meter, check for continuity between TP4 and TP18 and continuity between TP28 and TP19.

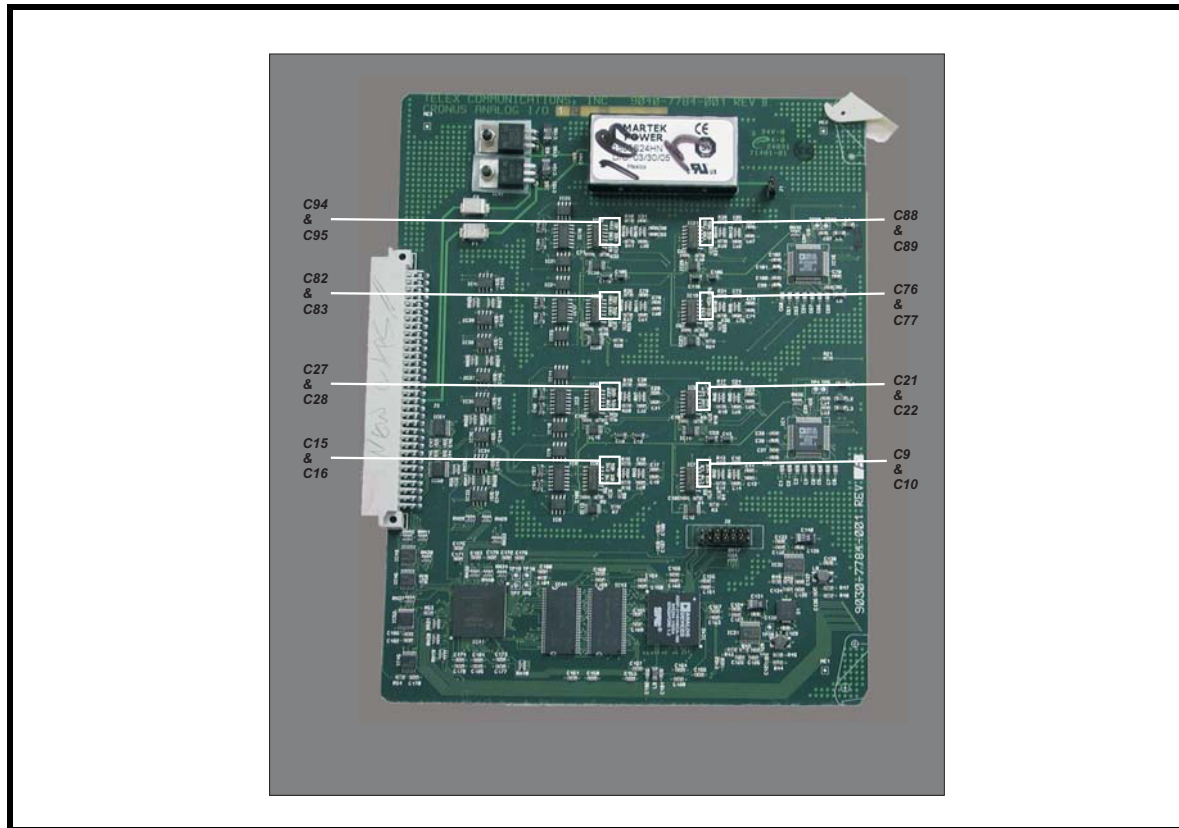
FIGURE 4. New AIO board capacitor placement

It was noticed that the frequency response starts dropping at 10KHz instead of 20KHz as specified in the User Manual.

To fix the Frequency Response problem, an EC #13-000341 was issued to replace 16 capacitors from 100pF to 12pF (part number 723411-14)

The 16 affected parts are C9, C10, C15, C16, C21, C22, C27, C28, C76, C77, C82, C83, C88, C89, C94 and C95.

The modified AIO front card should have the reference markup changed from 9030-7787-001 Rev B to Rev C. See figure 4.

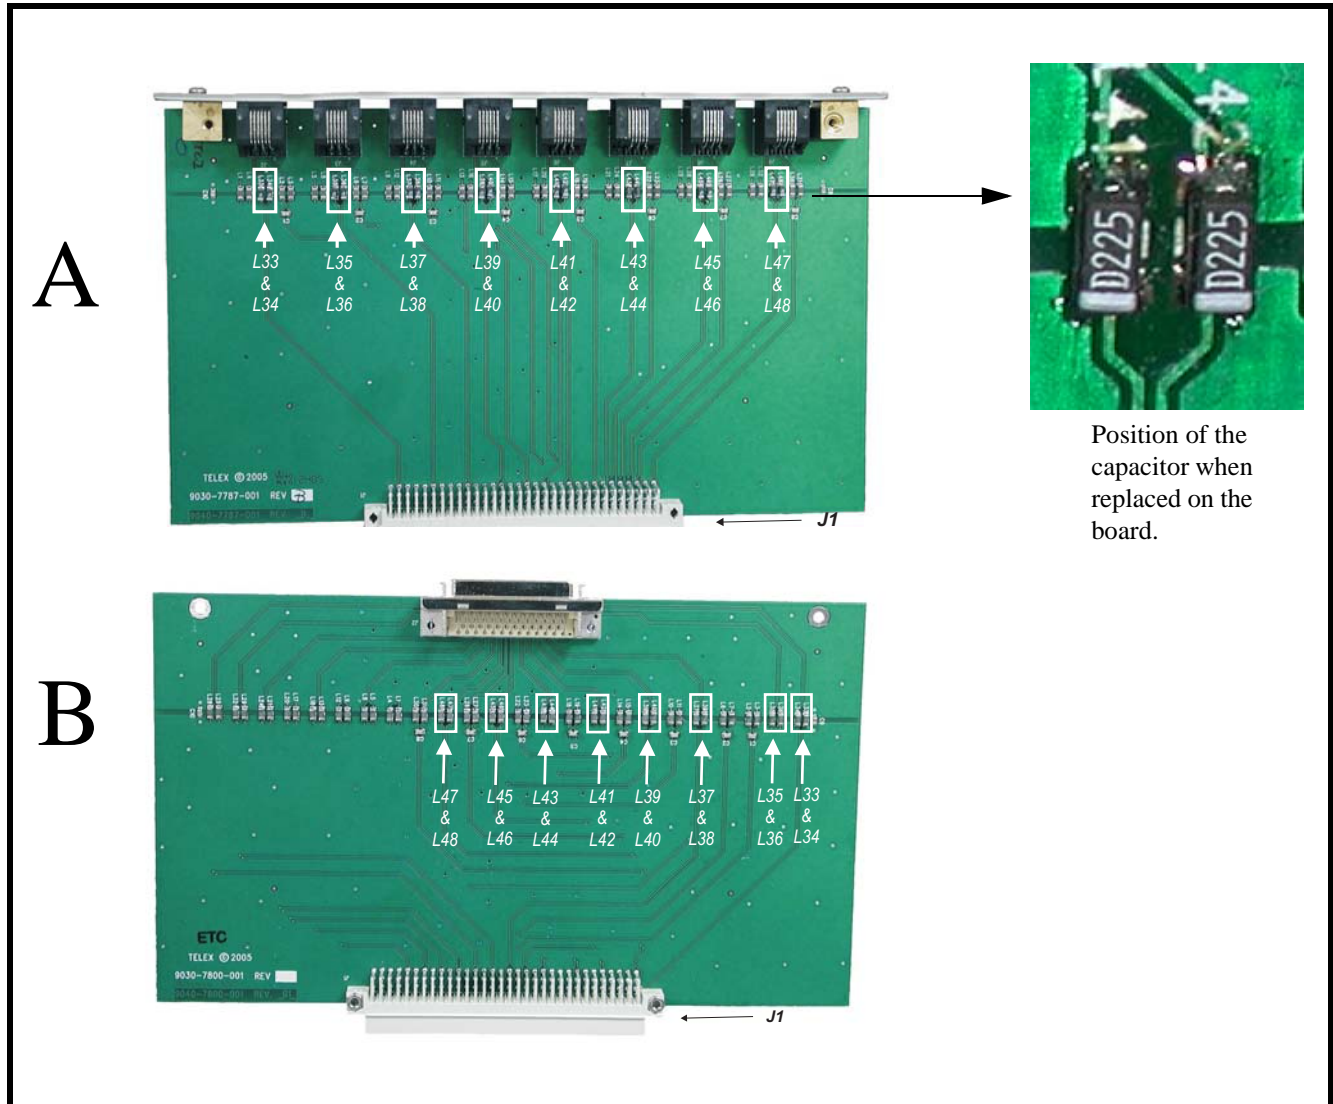
FIGURE 5. Capacitors on the RJ 12 (A) rear card and the MDR (B) rear card.

After changing the design to have an option for analog output gain up to +20dB, the AIO card (9030-7784-001) has exhibited DC bias voltage on the audio output differential pairs of +/- 1.8V.

To fix the DC Bias problem, two ECs were issued to replace the ferrite beads on the audio outputs of the AIO rear cards with DC blocking caps (4.7 uF/16V), part number 102877-070.

EC 46-000351 changes the RJ12 AIO rear card from 9030-7787-001 Rev B to Rev C (See reference A below).

EC 46-000361 changes the MDR Rear Card from 9030-7800-001 Rev A to Rev B (See reference B below).

The 16 affected parts are L33, L34, L35, L36, L37, L38, L39, L40, L41, L42, L43, L44, L45, L46, L47, L48.

IMPORTANT: The positive end of the capacitor should point toward J1 connector (see inset of figure above).

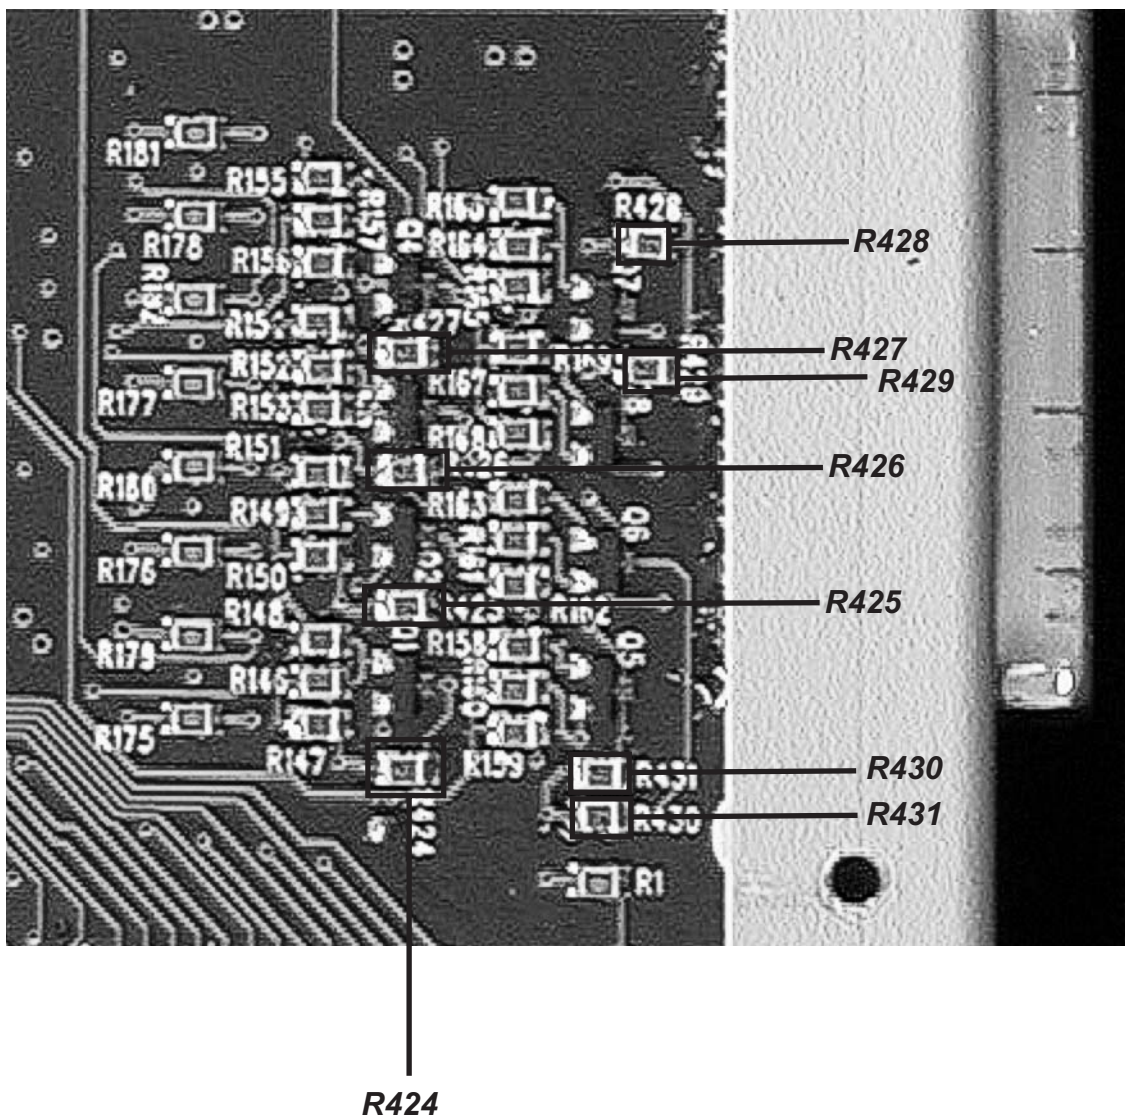
FIGURE 6. Resistor Changes on RVON-I/O (9030-7772-000)

The RVON-I/O's voltage drop across the GPO Output resistor is too large for the Cronus photo coupler GPI. The Cronus series resistor to the photo-coupler is also too large. The voltage drops across both resistors prohibit operation.

To fix this issue, change the RVON-I/O GPO Output from 22.1K to 6.19K on the RVON-I/O card and replace four resistors (R11 through R14) from 3 K to 470 Ohms.

1. On the RVON-I/O card remove **8 resistors (R24 through R431)** and replace with **6.19 K resistors (part number 102515-276)**. See Figure 1 for resistor placement.
