# *RVON-I/O*

## *Release*

## *Notes*

Since the release of the RVON-I/O card, a few issues have surfaced pertaining to the original card. This document covers these issues and how to fix the existing RVON-I/O board to solve these issues.

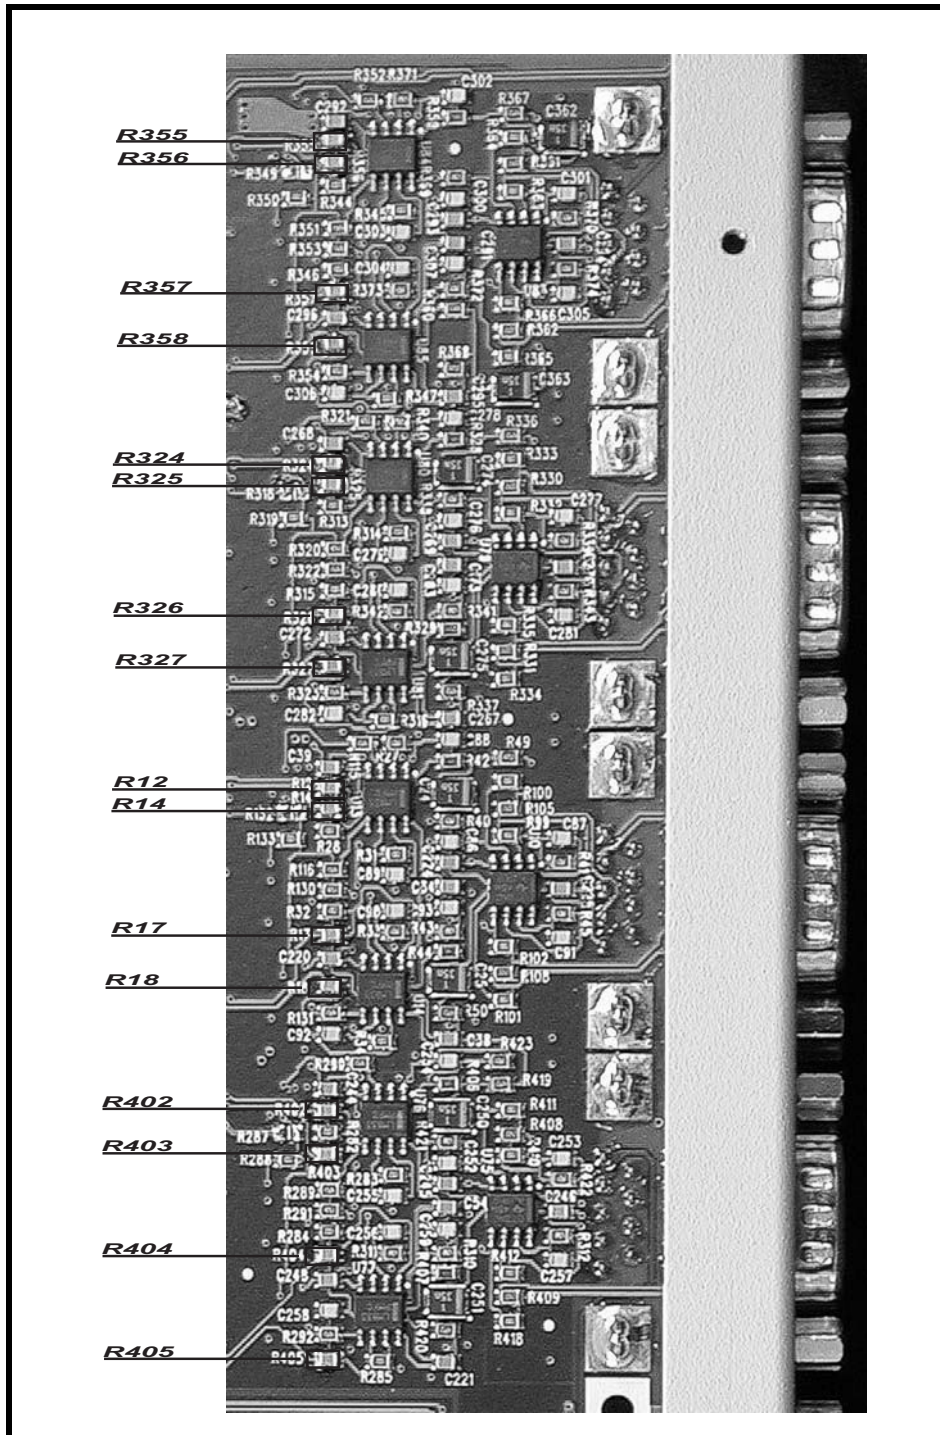
FIGURE 1. Crosstalk Resistors to Capacitors placement (board number 9030-7772-000).

### *Crosstalk on the same channel*

The output to the matrix is being heard on the same channel's input. The input to the Codec need to be AC coupled. To fix the crosstalk on the same channel, you must remove 16 resistors (150Ohm) - **R12, R14, R17, R18, R324 - R327, R355 - R358, R402 - R405** and replace with 16 capacitors (part number **102881-880**, 0.47 uF 16V) in **R12, R14, R17, R18, R324 - R327, R355 - R358, R402 - R405**. For replacement positions, see figure 1.

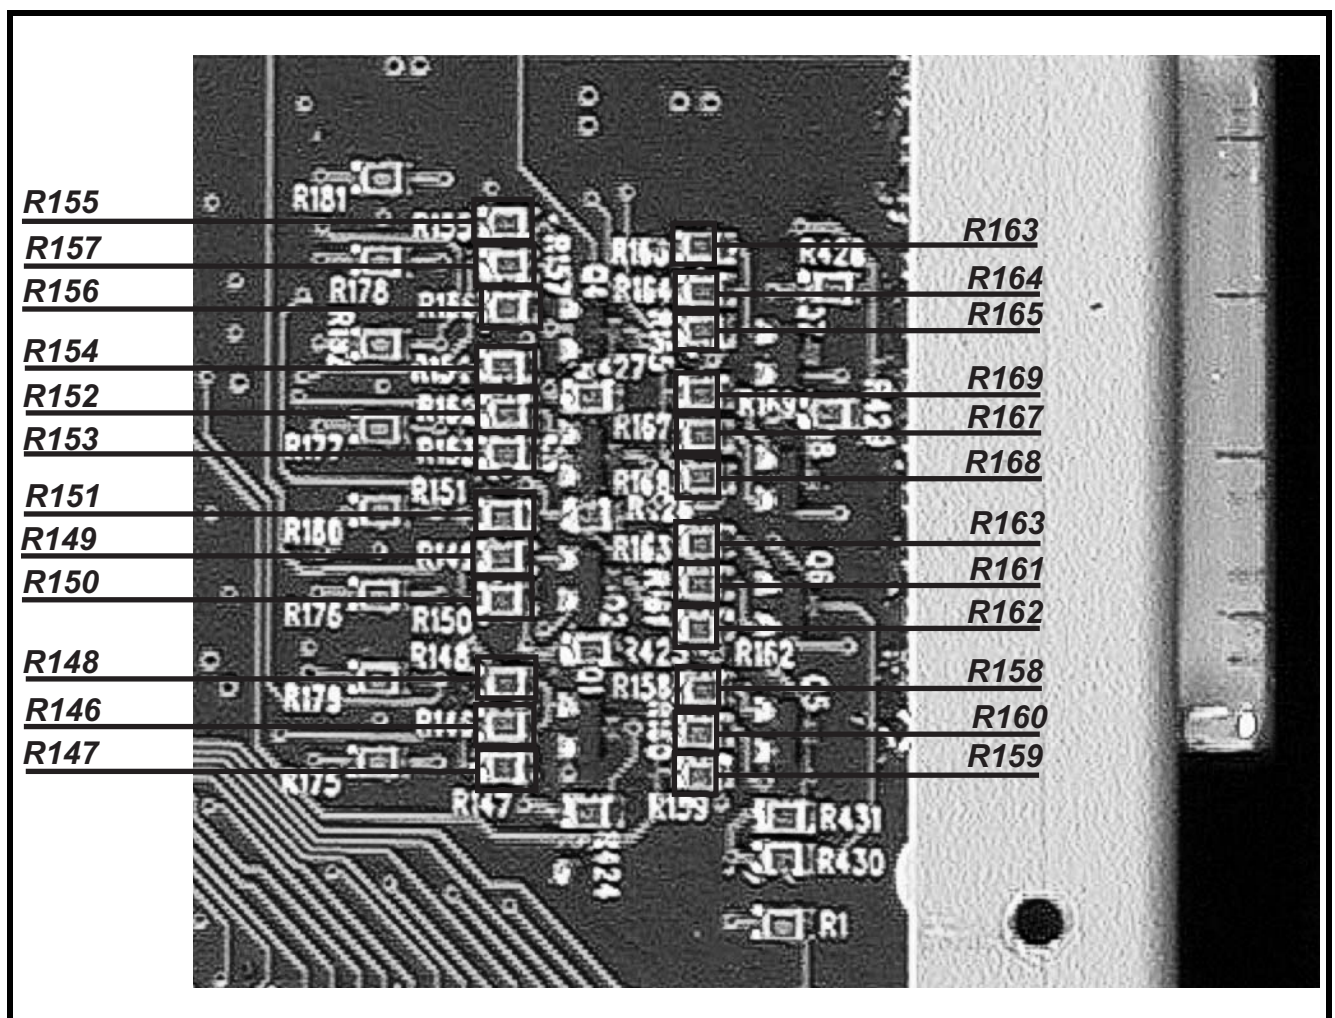
*When the RVON-I/O GPIO is connected to an ADAM frame with Redundant Controller Cards Installed, the RVON-I/O GPO is not able to drive both MCIIe GPI*

The GPO transistor can't handle the current load for a dual Master Controller chassis. The GPO transistor's input resistors need to be reduced to increase the base current. This will increase the collector current's load.

To fix this issue, change the 3 input resistors of each GPO from 22.1K to 2K. This increases the collector current from ~10 mA to ~60 mA. The transistor can handle 200 mA.

Also, remove 24 resistors, **R146 through R169** and replace them with 2K resistors (part number **102515-229**). See figure 2 for resistor placement.

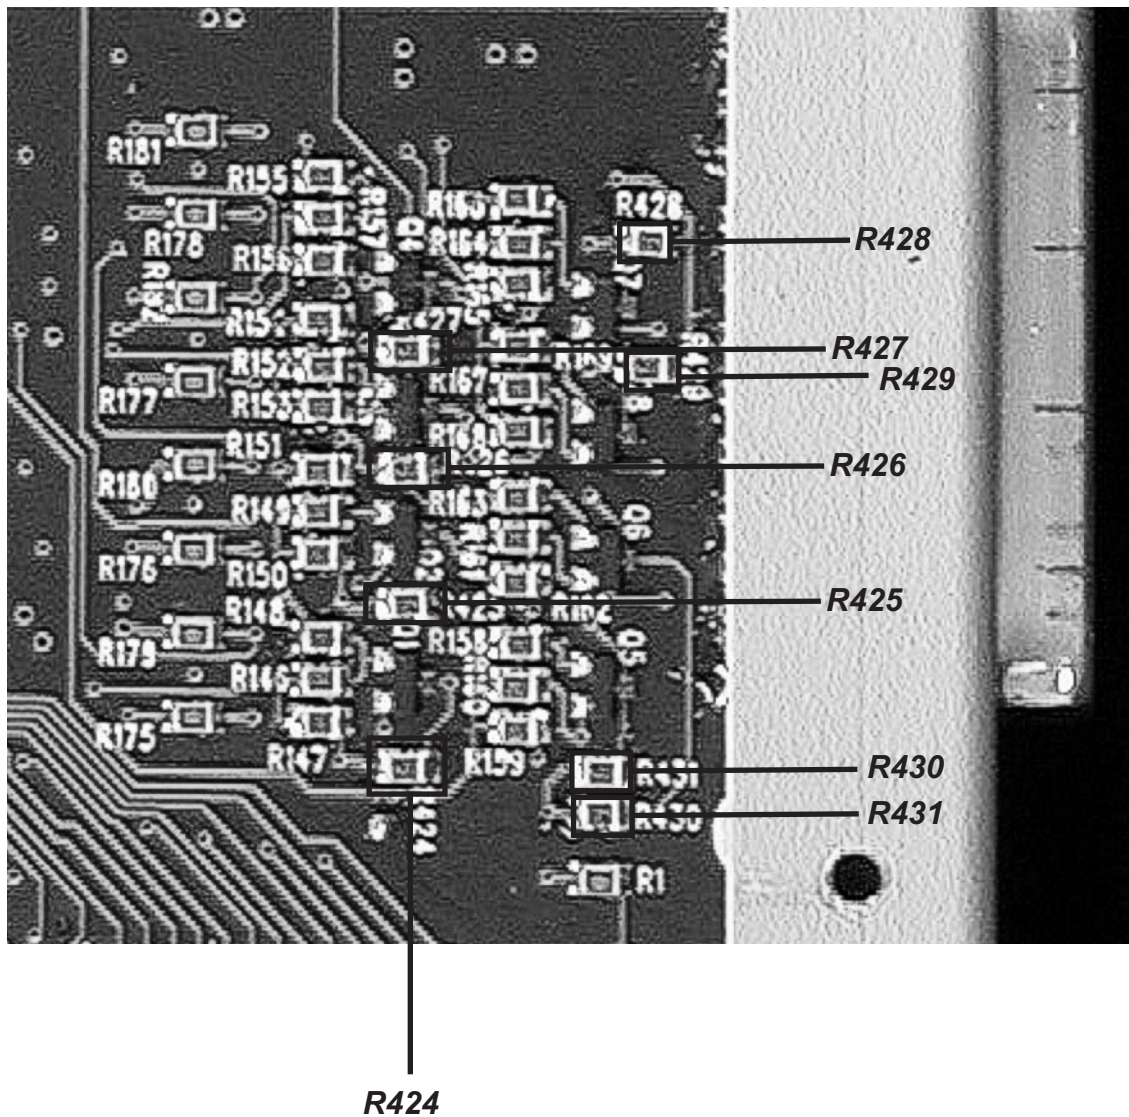
FIGURE 3. Resistor Changes

*When the RVON-I/O is connected to a Master Controller in a Cronus chassis, is not able to drive the Cronus GPI*

The RVON-I/O's voltage drop across the GPO output resistor is too large for the Cronus photo coupler GPI. The Cronus series resistor to the photo-coupler is also too large. The voltage drops across both resistors prohibit operation.

To fix this issue, change the RVON-I/O GPO Output from 22.1K to 6.19 K on the RVON-I/O card and replace four resistors (R11 through R14) from 3 K to 470 Ohms.

1. On the RVON-I/O card, remove 8 resistors (**R424 through R431**) and replace with 6.19 K resistors (part number **102515-276**). See figure 3 for resistor placement.
