Cronus

Release

Notes

Cronus Hardware Release Notes

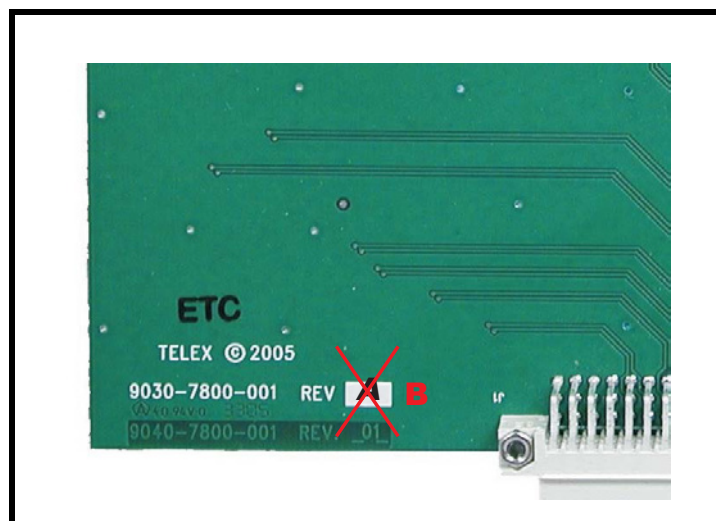
NOTE: Once you are finished making changes to the boards, the revision must be upped. See example below for the position of the updated revision.
